**MRD HYDRAULIC LABORATORY SERIES
REPORT NO. 9**

**LABORATORY INVESTIGATION OF
EROSION CONTROL USING HARD POINTS**

**MEAD HYDRAULIC LABORATORY
MEAD, NEBRASKA**

**U. S. ARMY ENGINEER DISTRICT, OMAHA
MISSOURI RIVER DIVISION, OMAHA
NOVEMBER 1977**

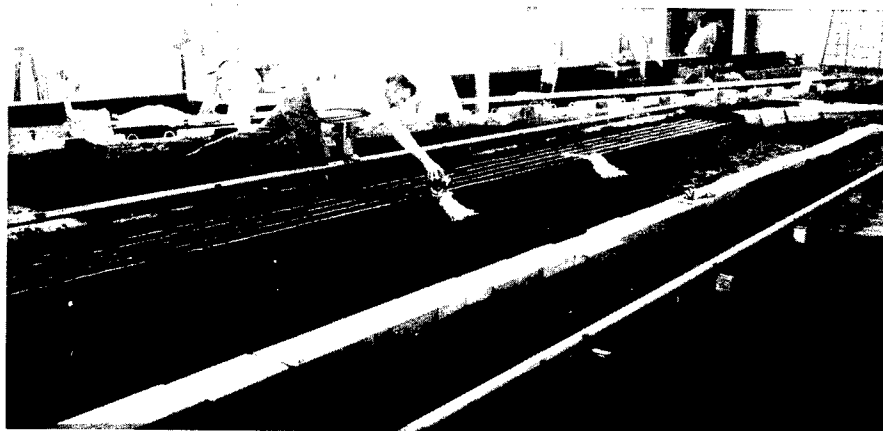
Picture 6: Placement of the rock used for the hard point structure formation.

After the channel bank was reformed, the selected hard point spacing interval was measured off and prepared for rock placement. Hard point structures require two types of rock placement, the root and the nose. A rectangular root trench was cut into the bank lines with the dimensions dictated by the preselected quantity of rock to be used. The trench was cut about a foot back and 0.2 foot deep and 0.4 foot wide. The trench was then filled with the specified quantity of rock per foot. The rock nose was formed by dumping the rock directly onto the channel bank and tied into the rock root. The process is shown in pictures 5 and 6. The gradation for the rock used in modeling the hard point structure was scaled down from the rock gradation currently being specified for hard points on the Missouri River. The gradation comparison is shown on plate 2.

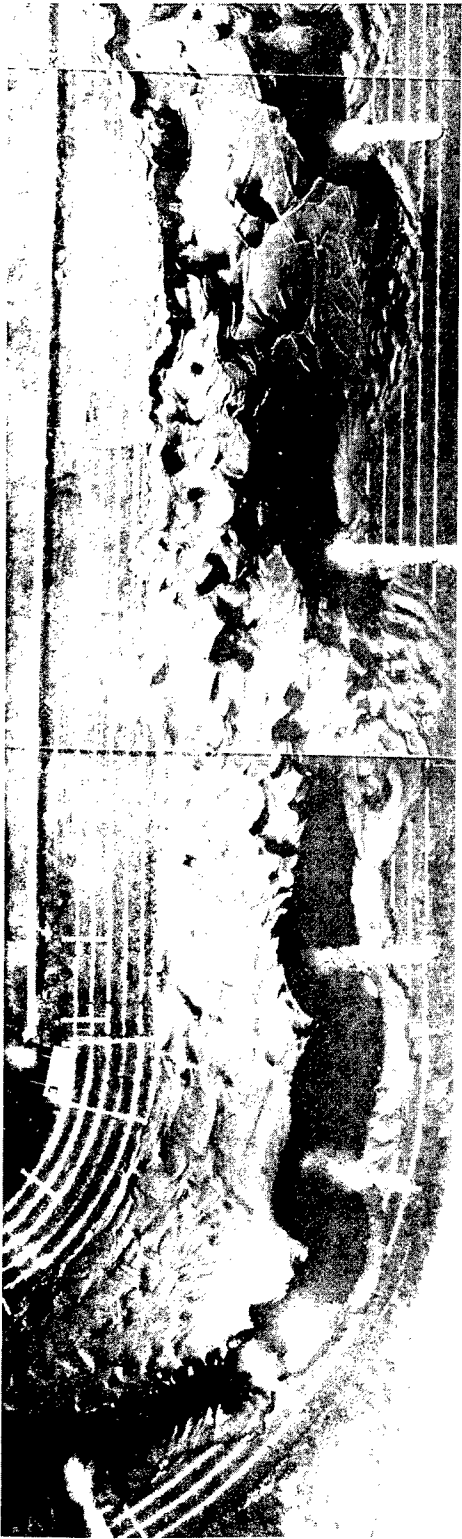
Picture 7: Failure of the hard points in the curve due to insufficient quantity of rock in the nose. The rock migrates to the bottom of the channel.

Initially, the tests involved the placing of hard point structures in the upstream curve and the straight reach at 5 and 7.5-foot intervals. For the initial tests, 4 lbs of rock were used in the nose and 3.5 lb/ft of rock were used in the root of each structure. This quantity of rock for the indicated discharge resulted in failure of the structures in both regions. The volume of rock was apparently insufficient to protect against the resulting scour which caused it to migrate to the bottom of the channel. Typical structure failures are shown in pictures 7 and 8.

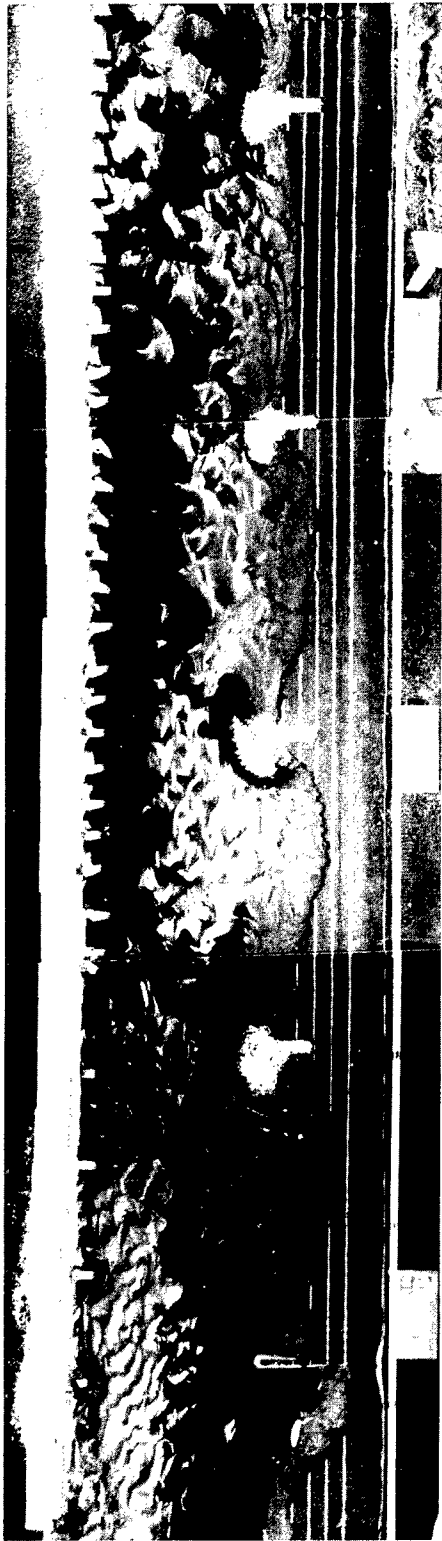
Picture 9: Development of erosion pattern with hard point roots aligned perpendicular to the channel bank.

The effects on the erosion pattern resulting from root alignment changes were observed with a 7.5 foot spacing and alignment angles of 60° and 30° . The angles were measured upstream from a line perpendicular to the channel. The erosion patterns for the tests are shown on pictures 9, 10, and 11. A comparison of the pictures shows the erosion patterns to be essentially the same. However, the erosion in the 60° alignment is less than that for both the 30° and the perpendicular alignment. The reason for this is that in the 60° alignment much of the root is, in effect, used for bank erosion protection. Unless the root is designed for this windrow type of protection there is no need for, nor particular benefit from, angular root alignment to the channel.

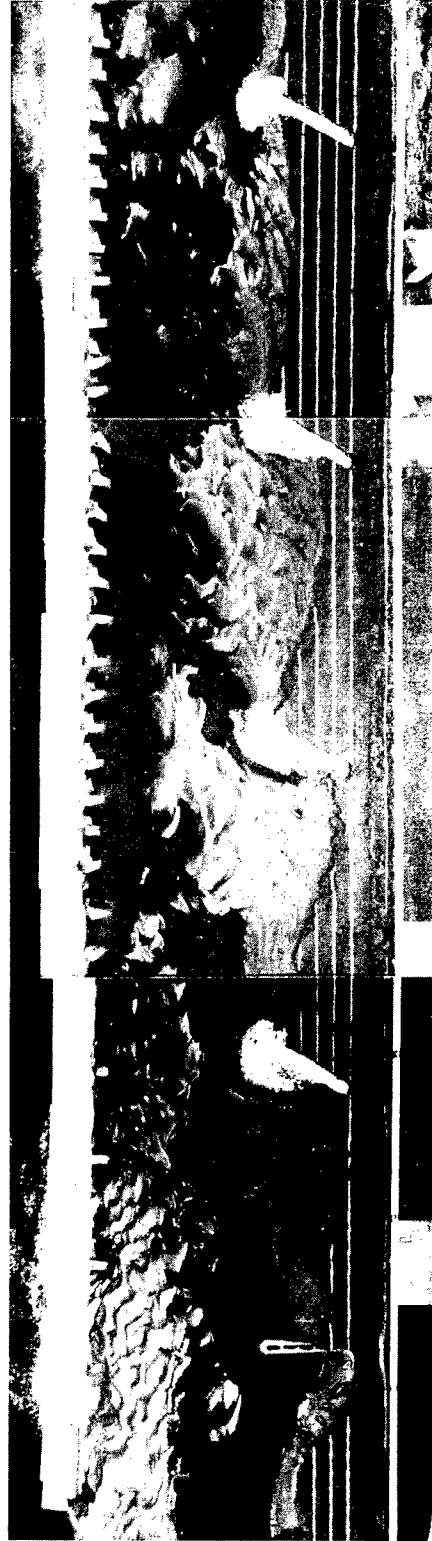
Picture 10: Development of erosion pattern with hard point root alignment at 30 degrees upstream from the perpendicular position. (Note the deterioration of the root.)
